Project report

AquaRockBag use to build
Biozone filled with Bimedia for
water cleaning and stop
erosion Johannesburg Area SA

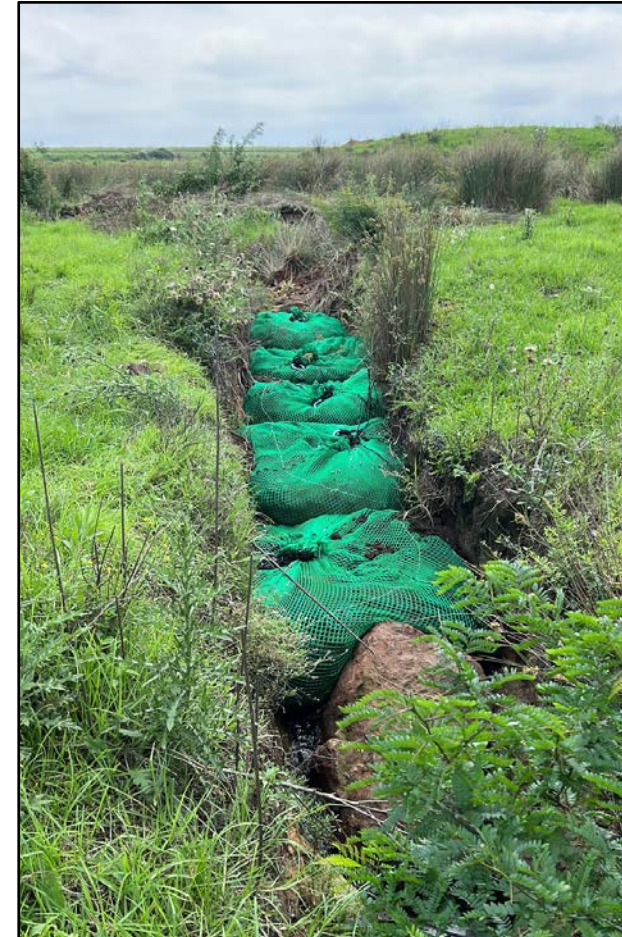
Design solution for channel erosion and water pollution – description of the planned structure and cost saving

- 150 (2T AquaRockBags®) – were used
- Installation was done on site within 2 days on site
- Used Bio Media and stones with double positive effect
- Cost savings in material, double efficient impact is approx. 60.000 €
- Unique solution as a medium for water purification.

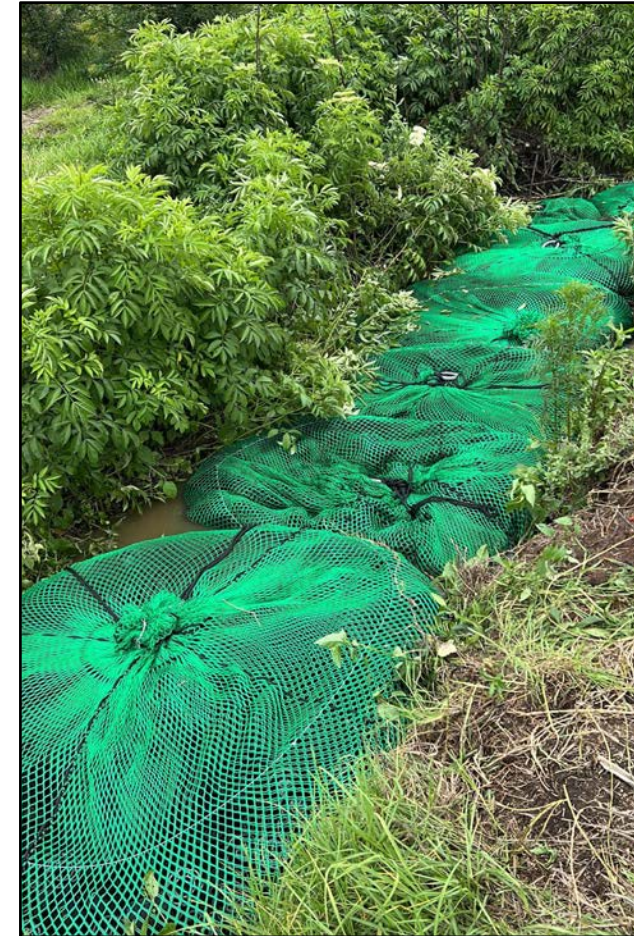
Reasons for choosing AquaRockBags[®]

- The AquaRockBag[®] filling and installation process is quick, safe and easy which results in big savings on labour costs. (In this project the bags were filled near channel and immediately installed.)
- The AquaRockBag[®] provides substratum for numerous faunal (Bio Disc)and invertebrate species which gives ecological benefit.
- AquaRockBags[®] absorb water energy, preserving natural processes and minimizing the impact on the substrate.
- The AquaRockBag[®] in this case perfectly blended to nature, more than sufficient bio protection and erosion protection
